Case No. 3:20-cv-00406-AJB-DDL

**EXPERT REPORT OF DEBRA
GRAHAM**

3 1. I have been retained by the Plaintiffs' counsel in this class action as an
4 environmental health and safety expert to review and inspect environmental health
5 and safety conditions at the San Diego County Sheriff's Department (Sheriff's
6 Department) jail facilities in San Diego, California. My review and inspections
7 focus on the core principles of public health and safety for staff, visitors, and
8 especially the incarcerated people who live in the Sheriff's Department jail facilities.

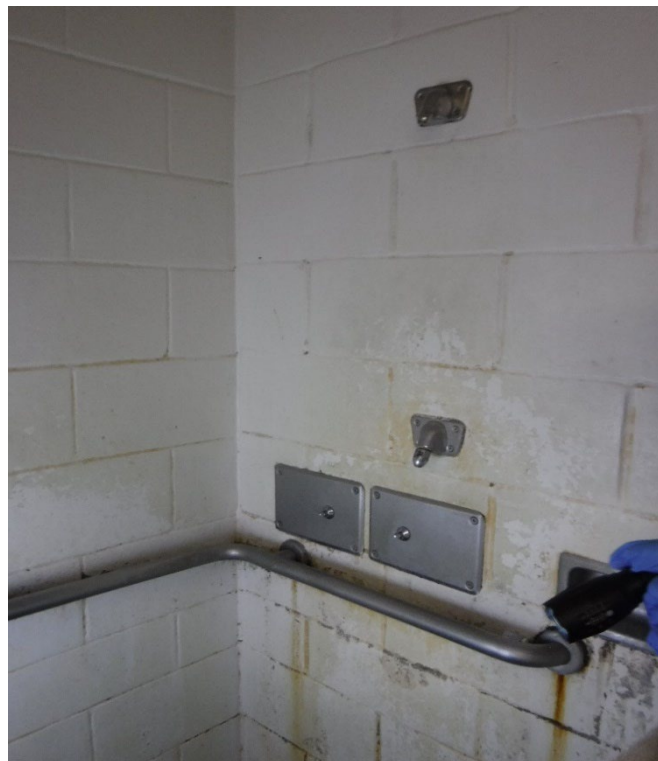
SD_742823 – George Bailey

13 26. Sinks, toilets, urinals, and showers were observed to be unclean
14 indicating that proper cleaning practices are not being performed. *See* Exhibit C at
15 SD_742870, SD_742973, SD_743174 and SD_1579295. Showers lack proper
16 cleaning as evidenced by visible soap scum, dirt, mold, and in some cases insect
17 infestations in the drains. Shower walls and ceilings were dirty and contained mold,
18 peeling paint, and water stains. Shower curtains were improperly hung mostly by a
19 string (*id.* SD_742833), a potential security/safety risk, and other showers had doors
20 hung that contain soap scum and/or mold. Many toilets were also found unclean,
21 with varying degrees of dirt, mold, and/or filth. *Id.* SD_742695 and SD_1579296.
22 At Vista, clothing items were observed in the toilet in the male holding cell named
23 “Male Phone.” *Id.* SD_743258. Some toilets and showers were so filthy that even

24 someone untrained in cleanliness and sanitation practices will know that the
25 conditions are unacceptable and cleaning is needed:

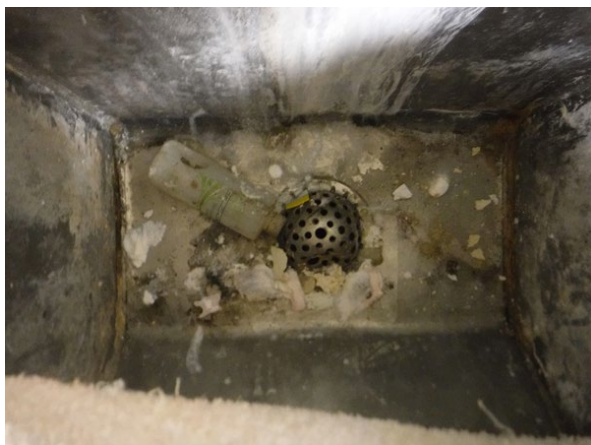
18 SD_742974 – George Bailey

2 33. In George Bailey, in incarcerated persons' areas, sinks and toilets were
3 observed as stainless-steel sink/toilet combination units or stainless-steel toilets, and
4 separate stainless-steel sinks, and urinals are available as separate units. Many of these
5 units throughout George Bailey were observed dirty as evidenced by stains, soap scum,
6 and dust/dirt in and on sinks (*id.* SD_742665 – Holding number 107), and stains, scum,
7 excrement, and filth in and on toilets. *Id.* SD_742695 – Holding number 102,
8 SD_742663 – Holding number 107, SD_742682, SD_742860 and SD_742871. A
9 filthy urinal was observed in the bathroom of Module 1B covered with a dirty towel.
10 Drain flies were also observed in this urinal once the towel was lifted:

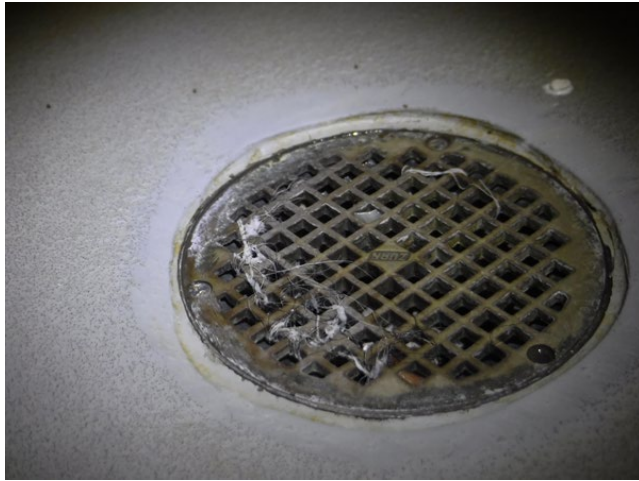
SD_742831 – George Bailey

6 28. Drains in showers, padded cells, and individual sinks were found in
7 need of cleaning. *See id.* at SD_742831, SD_743148 and SD_743307. Drain flies
8 were observed at George Bailey in medical observation number 102, at Central Jail,
9 and at South Bay. Debris and dirt were also found in drains inside some padded
10 cells. The Sheriff's Department's apparent unwillingness to keep these areas clean
11 is illustrated by the experience of Plaintiff Darryl Dunsmore, who was "forced to
12 sleep among his own feces and other trash" in an Enhanced Observation Housing
13 ("EOH") cell while incarcerated. Plaintiff Darryl Dunsmore's Response to
14 Defendants' Special Interrogatory No. 10.

19 34. Showers were observed to be dirty, many in need of scrubbing and
20 repairs, as evidenced by accumulated soap scum, dirt, mold, and peeling paint. *Id.*
21 SD_743054, SD_743088, SD_743114, SD_743146, SD_742779, SD_742823 and
22 SD_742963. In some areas, shower curtains were improperly hung, some in a
23 makeshift manner such as by a string and were dirty, contained soap scum, and were
24 moldy. *Id.* SD_742832, SD_742834, SD_742929 and SD_742962. Shower drains
25 were dirty and clogged, indicating a lack of routine cleaning, scrubbing, and
26 flushing. *Id.* SD_743148, SD_742829, SD_743089 and SD_743110. Drain flies
27 were observed crawling in and about the shower drain and on the floor in Medical
28 Observation number 102.

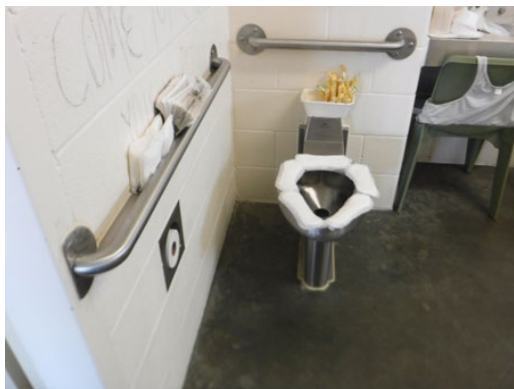
SD_744384 – Las Colinas

21 55. In incarcerated persons' areas, sinks and toilets were observed as
22 stainless-steel sink/toilet combination units or stainless-steel toilets and separate
23 stainless-steel sinks. While toilets and sinks at Las Colinas were observed cleaner
24 than George Bailey, Vista, or Central Jail, some were observed to be unsanitary as
25 evidenced by stains, scum, garbage, and/or filth in and on sinks and/or toilets. *Id.*
26 SD_744048 – Sobering Cell number 2, SD_744116 – Medical Ward 3, SD_744261
27 – Unit 5A and SD_744570 – Triage. There was also a systemic issue with feminine
28 sanitary pads being stuck to stainless steel toilet seats. *Id.* SD_744101 – Safety Cell

1 Step Down, SD_744117, SD_745565 – Unit 5A, SD_744384 – Unit 4A and
2 SD_744499. Toilets were also observed with sanitary pad adhesive still stuck to
3 them (*id.* SD_743983 – Intake and SD_744603), even though the sanitary pad had
4 been removed. This indicates covering toilet seats with sanitary pads is a common
5 practice. In some cases, the adhesive was observed dirty, which is evidence that it
6 had been stuck to the toilet seat for some time and was not easily removed. *Id.*
7 SD_744455. Adhering sanitary pads to toilet seats is a very unsanitary practice, as
8 the toilet seat cannot be properly cleaned and disinfected while sanitary pads and/or
9 adhesive are stuck to them.

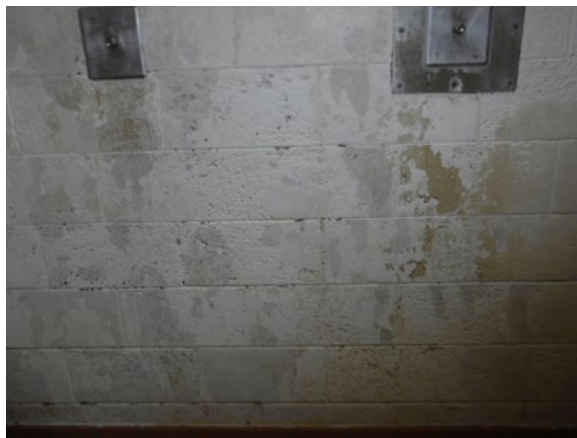
SD_745242 – East Mesa Reentry Facility

23 63. In the housing areas, showers are large areas with multiple shower
24 heads. These showers were consistently observed with dirty walls, stained walls,
25 soap scum, and mold on both shower walls and floors. *Id.* SD_744891 – D1,
26 SD_744950 – D2, SD_745235 – A1, SD_745242 – A1, SD_745299 – A2,
27 SD_745302, SD_745316 – A2 and SD_745440 – C2. Shower drains were observed
28 in need of cleaning, some contained scum and debris and some were observed with

1 mold. *Id.* SD_744893 – D1, SD_745349 – C1, SD_745241 – A1, SD_745310 – A2,
2 SD_745315 – A2, SD_745442 – C2 and SD_745443 – C2. Some shower walls
3 were in disrepair as well, with peeling paint and uneven surfaces. *Id.* SD_745256 –
4 A1, SD_745346 – C1, SD_745348 – C1, SD_745444 – C2 and SD_745447 – C2.
5 Shower walls and floors in disrepair allow for the harboring and growth of bacteria
6 and fungus. In addition, shower walls, floors, and drains that are dirty, contain soap
7 scum, and/or are moldy can spread disease and cause respiratory issues. These
8 photographs illustrate some of the shower conditions described above:

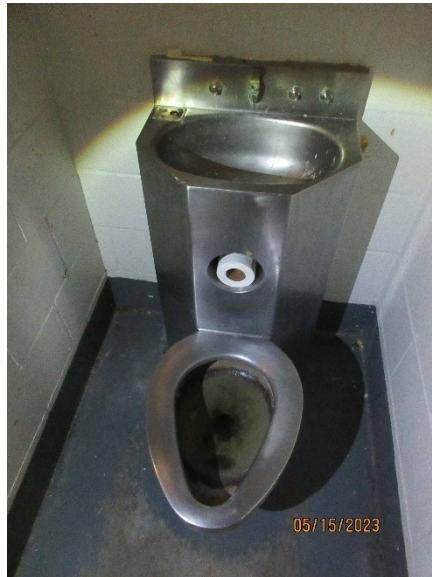
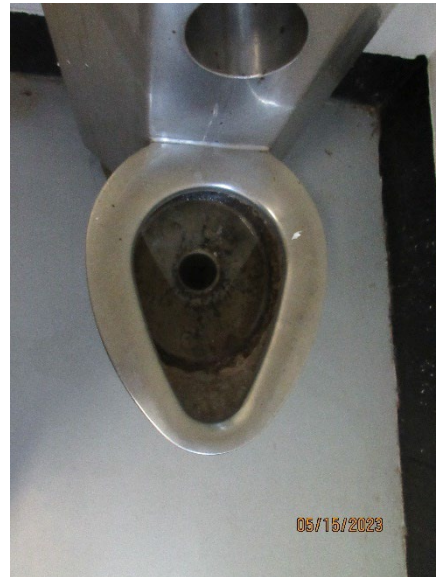
1 stainless-steel sinks. Throughout Central Jail, the sinks and toilets were observed
2 dirty as evidenced by stains, soap scum, dust, dirt, and trash in and on sinks. *Id.*
3 SD_1579355 – PSU and SD_1579621 – Holding. Stains, scum, excrement, and
4 filth were observed in and on toilets. The majority of toilets observed in this facility
5 were filthy. *Id.* SD_1579304 – Court Holding number 4, SD_1579309 – Court
6 Holding number 8, SD_1579354 – PSU and SD_1579433 – D04. The photographs
7 below illustrate some of the sink/toilet conditions described above:

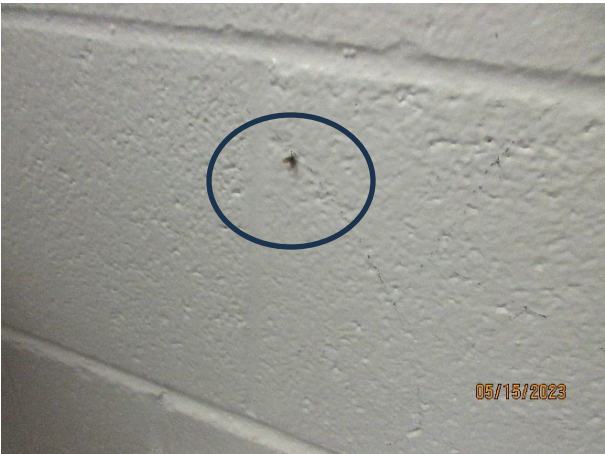
SD_1579486 – Central Jail

1 SD_1579578 – Module 8C, SD_1579639 and SD_1579656 – Module 4B. Shower
2 drains were observed dirty, with hair and debris on drain grates, and debris and
3 slime inside drains. *Id.* SD_1579371 – PSU, SD_1579376 – PSU, SD_1579470 –
4 Module 8A and SD_1579581 and SD_1579583 – Module 8C. Drain flies were
5 observed crawling in and about sink and shower drains and on walls in multiple
6 areas of Central Jail. *Id.* SD_1579485 (sink) – 6th Floor Holding, SD_1579486
7 (wall) – 6th Floor Holding, SD_1579544 – Module 8C, SD_1579554 – Module 8C
8 and SD_1579641 – Module 5A. In the Psychiatric Stabilization Unit (PSU), drain
9 flies were observed in the shower drain and the drain had a strong foul smell. In
10 Module 8C, many live dark worms (drain fly larvae) in various stages of maturity
11 were observed crawling in and around a dirty drain and in pooled water outside of
12 the showers on the upper tier. *Id.* SD_1579564, SD_1579566, SD_1579568 and

13 SD_1579571. The below photographs illustrate some of the shower and drain
14 conditions described above:

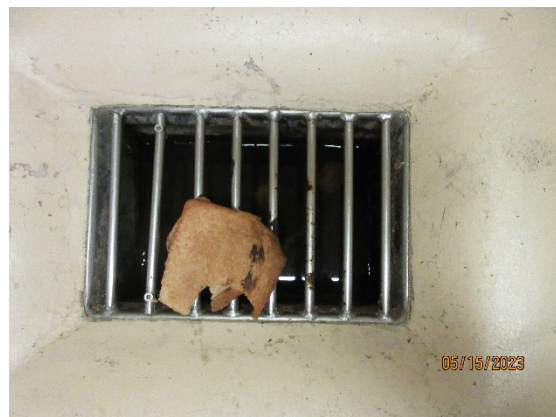
11 79. Inside safety cells numbers 1 and 2 and padded cell number 2095, the
12 floor drains, the drain grate, and the area
13 around the floor drains were observed to be
14 dirty and the floor drains contained standing
15 water. In safety cell number 2, bread was
16 lying on the drain grate. *Id.* SD_1579326 –
17 safety cell number 2 (at right), SD_1579329 –
18 safety cell number 1 and SD_1579321 –

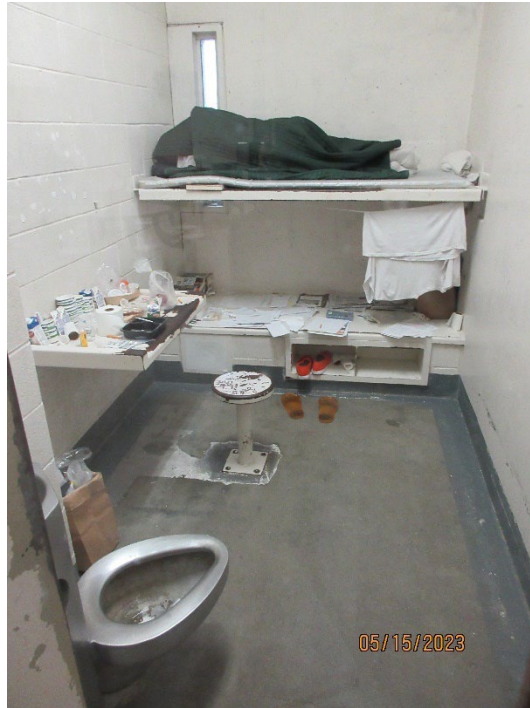
14 SD_1579439 – Central Jail

23 80. Incarcerated persons' living and holding areas were observed cluttered,
24 trash was on floors and outside receptacles, filthy trash cans with no liner containing
25 trash, towels, and linens were on floors, and food containers from previous meals
26 that still contained food were observed in multiple cells. *Id.* SD_1579308 – Court
27 Holding number 8, SD_1579439 – Module 7D (cell D10), SD_1579441 – Module
28 7D (cell D08), SD_1579623 – 8th Floor Holding, SD_1579447 – Module 7D and

1 SD_1579555 – Module 8C. The photographs below illustrate the conditions
2 described above.

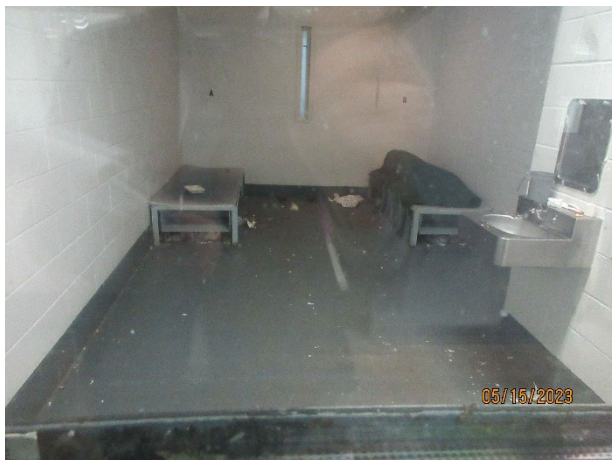
SD_1579380 – Central Jail

1 6E where the desk, stool, and bunk were in much better shape than the majority of
2 others observed, and it appeared that these items may have recently been painted.
3 *Id.* SD_1579512. PSU 2 was observed with one incarcerated person sleeping under
4 a blanket on one of two metal single bunks, and trash was observed throughout the
5 entire area on the floor and under the bunks:

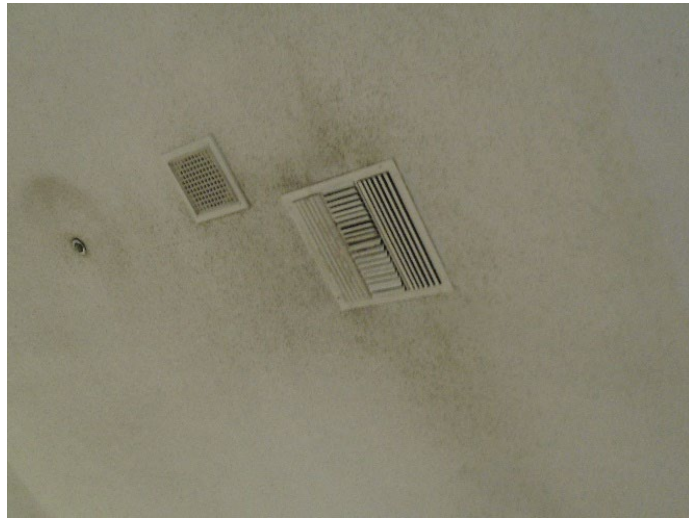
SD_1579054 – South Bay

28 101. Ceilings were observed dirty, had peeling paint, and accumulated dust

1 across ceilings from dirty air vents. *Id.* SD_1579084 – 1B, SD_1579054 – 1B,
2 SD_1579246 – 2A, SD_1579274 – 2B and SD_1579291 – 4A. Air vents were also
3 observed rusted, moldy, clogged, or blocked. *Id.* SD_1579021 – 3A, SD_1579116,
4 SD_1579130 – CT2, SD_1579250 – 2A (cell 21), SD_1579260 – 2A (cell 24),
5 SD_1579270 – 2B and SD_1579271 – 2B. In housing unit 2A (cell 13), a screw
6 meant to secure the air vent was sticking partially out of the wall and air vent. *Id.*
7 SD_1579245. The photographs below illustrate some of the ceiling observations.

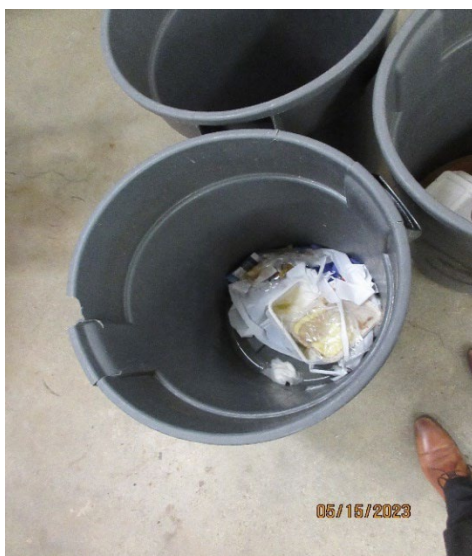
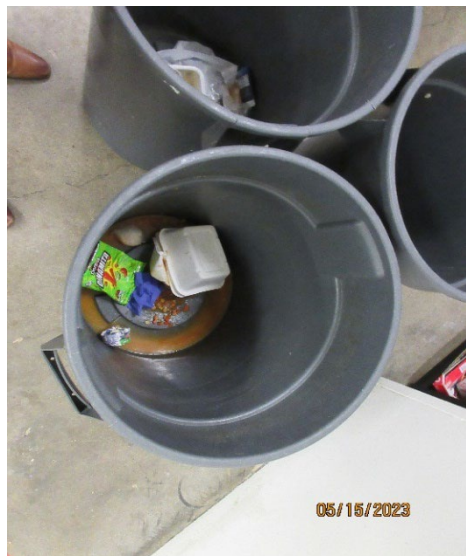
SD_1579194 – South Bay SD_1579196 – South Bay

102. Throughout South Bay, cells were observed cluttered and dirty, containing excessive amounts of food items, food trays that contained old food from previous meals, and self-made clotheslines with towels and clothing items hanging from them. *Id.* SD_1579080 – 1B (cell 2). Many cells were observed with excessive amounts of books and papers. In Unit 1B (cell 1), there was so much clutter, books, papers, meal trays, food, etc., that the cell was a fire hazard. *Id.* SD_1579067, SD_1579070 and SD_1579076. In Unit 3B, unlined trash cans were observed with trash, food items, and fluid inside. *Id.* SD_1579194 and SD_1579196.

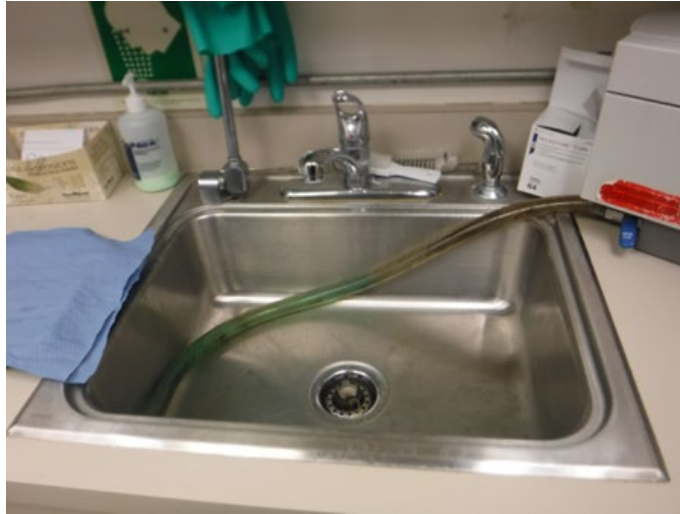
SD_743831 – Vista

22 110. The dental room is of particular concern. The door threshold into the
23 dental room was very dirty. *Id.* SD_743834. The dental room floor was dirty as
24 well, multiple boxes were sitting on the floor, and various tubing was also lying on
25 the floor. *Id.* SD_743826 and SD_743828. There was a bucket sitting on the floor
26 with unknown contents and a dirty biohazard container sitting next to the bucket.
27 *Id.* SD_743829. The instrument cleaning/washing sink was dirty, a filthy molded
28 drain tubing was lying in this sink, and brushes were lying in the open on the back

1 of the sink:

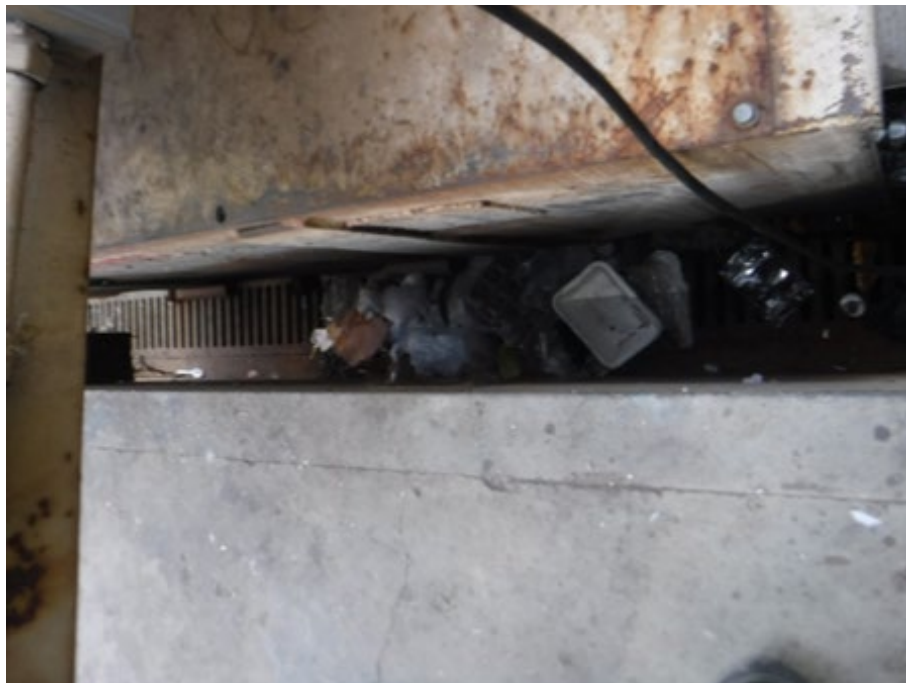
SD_743872 – Vista (Kitchen dumpster ground area)

4 146. The condition of the kitchen dumpster area was unacceptable and
5 unsanitary. Everything about the loading dock and dumpster areas was filthy with
6 accumulated trash, debris, food, and filth all around the dumpster area, the wall of
7 the loading dock, the stairs from the loading dock to the lower ground level, and
8 between the loading dock and the dumpster. There is a trench drain running the
9 length of the base of the loading dock that was also filthy, with debris on and in the
10 drain, and standing water in the drain. The trench drain grate needed scrubbing as
11 well. *Id.* SD_743871, SD_743872, SD_743873, SD_743876, SD_743877,
12 SD_743880 and SD_743881. These photographs illustrate the conditions observed
13 at Vista loading dock and dumpster area:

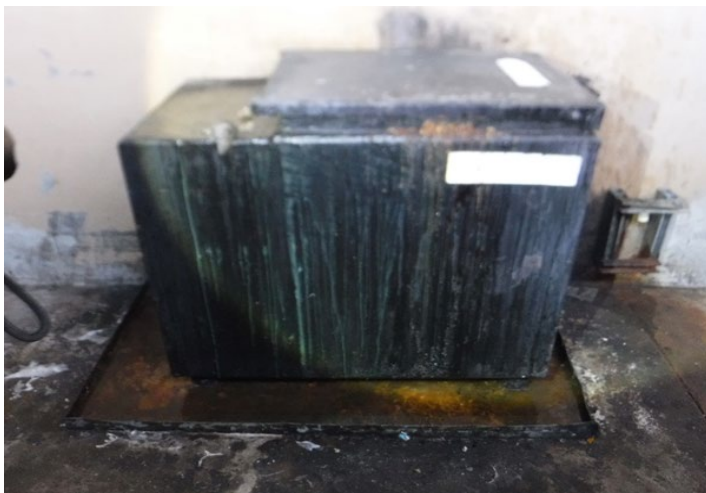
17 SD_743885 – Vista (Kitchen loading dock)

1 147. The grease bin/trap was filthy and was standing in water. The entire
2 area around this bin was also filthy. *Id.* SD_743885 and SD_743886. The ground
3 was full of old grease and was in disrepair. The walls were also filthy, with old
4 grease, and were in disrepair, with peeling paint at the upper levels. *Id.* SD_743888.

5 148. The grease bin/trap was observed with a dead rat lying on top of the
6 bin. *Id.* SD_743887. This entire area was unacceptable, unsanitary, and a huge
7 attractant for rodents, cockroaches, and other pests. The photographs below show
8 the conditions observed around the grease bin/trap:

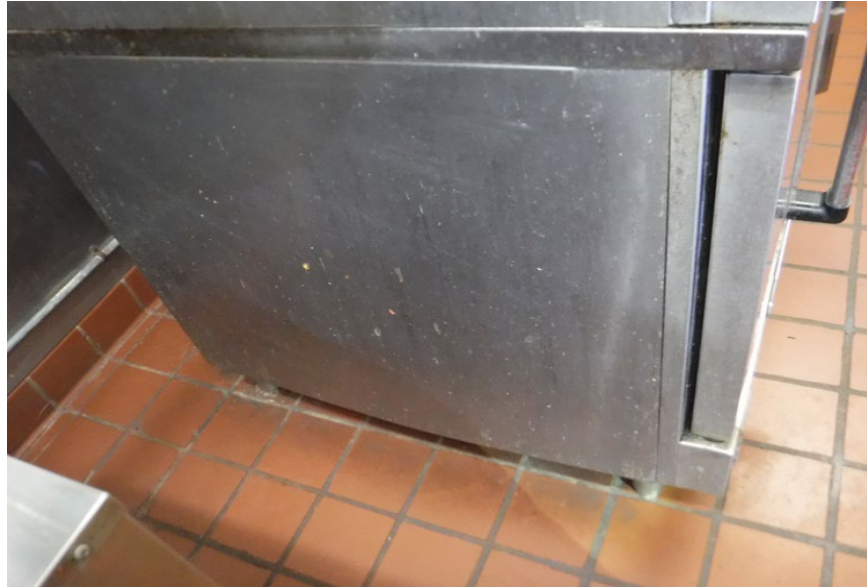
11 SD_743898 – Vista (Kitchen)

¹¹ FDA Food Code 2022 – Chapter 4, Paragraph 4-601.11 C, Nonfood-contact surfaces of equipment shall be kept free of an accumulation of dust, dirt, food residue, and other debris.

1 example of dirty cooking equipment observed in the kitchen at Vista:

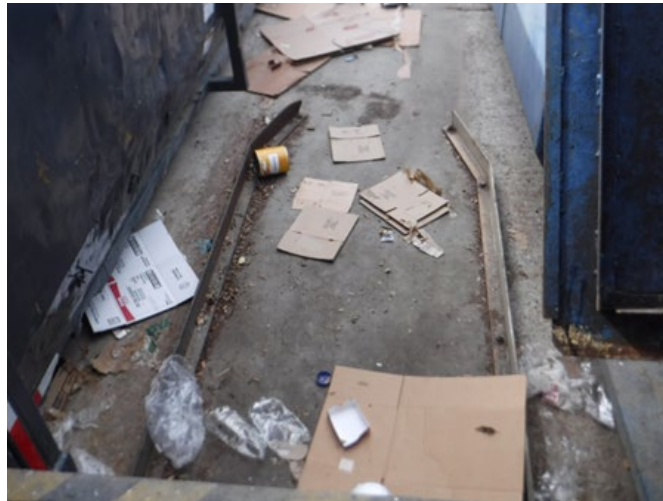
SD_745510 – East Mesa Kitchen (Dumpster area)

2 158. The loading dock and dumpster area of this kitchen are of great
3 concern. The dumpster and entire dumpster area were observed beyond filthy, with
4 accumulated trash, food, debris, and filth around the dumpster, and between the
5 loading dock and dumpster. *Id.* SD_745510 and SD_745515. East Mesa is failing
6 to keep its dumpster area clean and is in direct violation of Chapter 5¹³ of the FDA
7 Food Code 2022, and Chapter 7¹⁴ of the California Department of Public Health,
8 California Retail Food Code. The excessive amount of accumulation of trash, food,
9 debris, and filth indicates that the dumpster area is not maintained at an acceptable
10 level for proper food safety. These photographs illustrate the conditions observed at
11 East Mesa kitchen dumpster area:

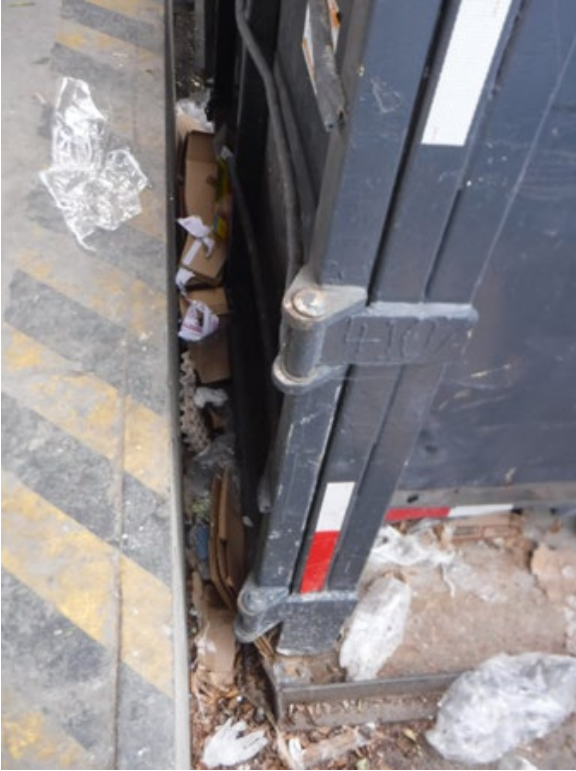
SD_745511 – East Mesa Kitchen (Dumpster area)

26 ¹⁴ California Department of Public Health, Division 104 Environmental Health,
27 Part 7. California Retail Food Code, Chapter 7, Article 4. Refuse, 11445.5
28 “Receptacles and waste handling units for refuse and recyclables shall be installed
so that accumulation of debris and insect and rodent attraction and harborage are
minimized and effective cleaning is facilitated around and, if the unit is not installed
flush with the base pad, under the unit.”

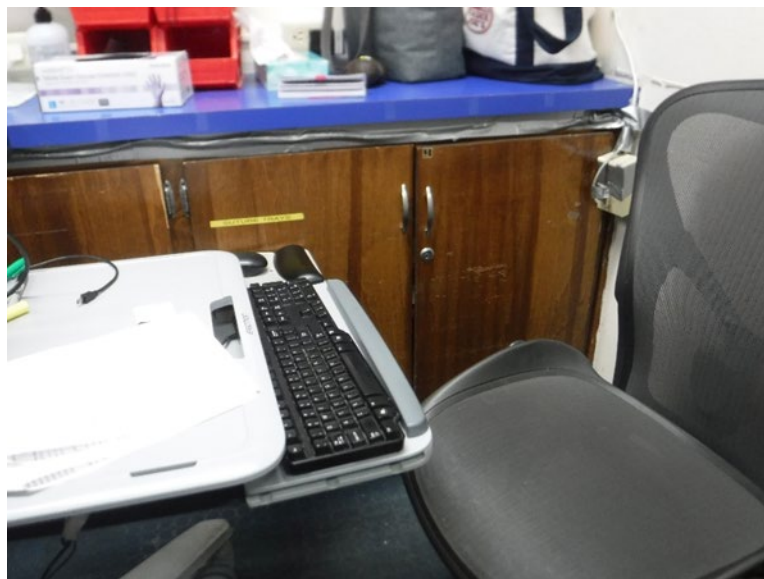
SD_743806 (Clinic)

13 192. In medical clinic number 1 at Vista, duct tape was holding an electrical
14 cord along a cabinet and also into an electrical outlet:

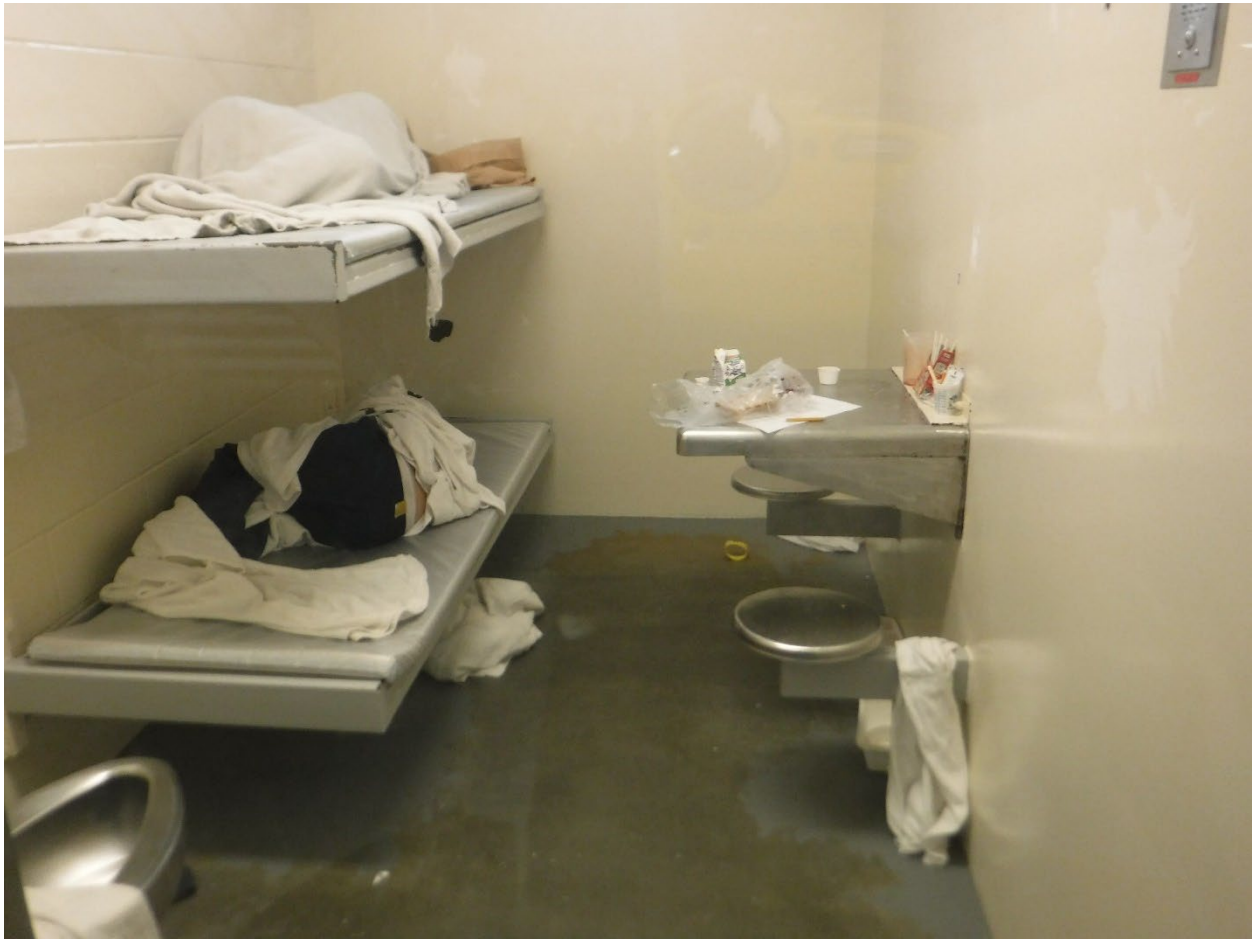
SD_743606

27. Floors were observed in disrepair in bathrooms (*id.* SD_742958) and housing units (*id.* SD_743606, SD_743748 and SD_1579424), which presents ample space for the breeding/growth of bacteria, and in many areas, floors were visibly dirty as well. Wall paint in housing units (*id.* SD_743622), around telephones (*id.* SD_743280, SD_743763 and SD_1579036), and in showers (*id.*

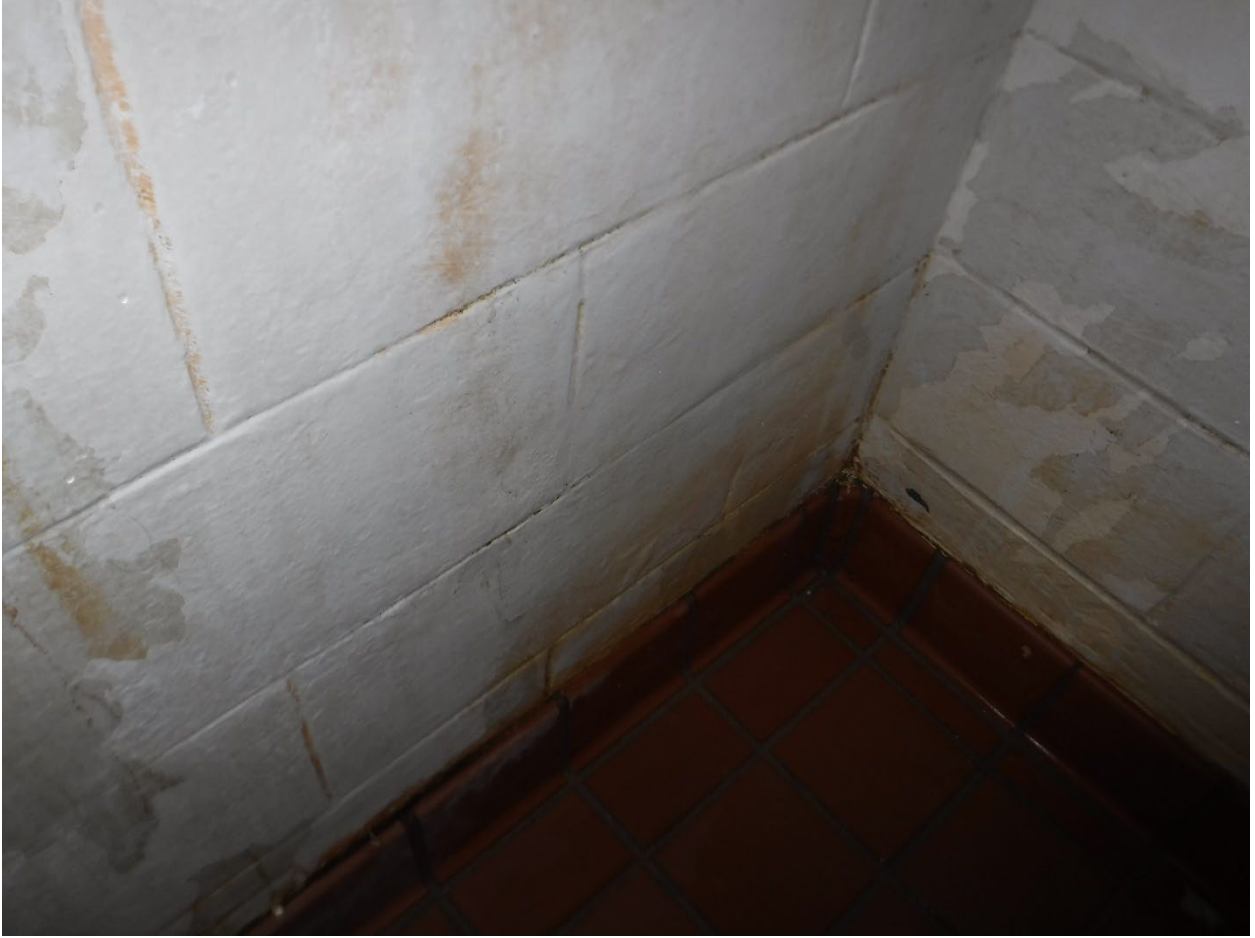
SD_745256

1 SD_745256) was chipped and peeling, also providing ample space for bacterial
2 growth, spread of disease, and fungal infections. Ceilings, ceiling tiles, and air vents
3 in many housing units, especially at George Bailey were filthy, with an excessive
4 amount of dirt and dust on them. Cell air vents were rusted and contained dust,
5 many with debris covering the vent(s).
